Systematic analysis of induction coil failures

PART 2: EFFECT OF CURRENT FLOW ON CRACK PROPAGATION

by Valery I. Rudnev • Inductoheat Group

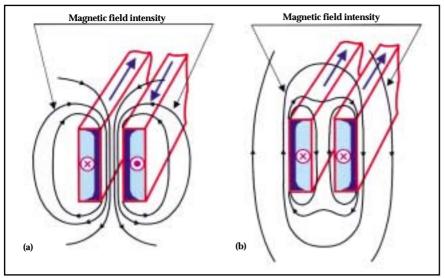
Another electromagnetic phenomenon that dramatically affects the current distribution within a current-carrying conductor is the proximity effect. Details about this effect are discussed in Ref. 1. Figure 2 shows the current distribution in copper bars when electrical currents flow in opposite directions (a) or in the same direction (b).

Fig. 2 — Current distribution in current-carrying copper bars due to the proximity effect. (a) Currents flowing in opposite directions. (b) Currents flowing in the same direction.
